## Remediation of the HPP "Višegrad" Dam

Dejan Divac, Dušan Mikavica, Zoran Dankov, Maja Pavić, Rajko Vasić

**Abstract:** The hydropower plant "Višegrad" is located on the Drina River upstream of Višegrad. Many seepage occurrences have been observed since the construction. Over time, the measured quantities of seepage water under the dam body increased significantly: from 1.4 m<sup>3</sup>/s (1990) to 14.68 m<sup>3</sup>/s (2012). Investigations were implemented during 2008-2009 period to define the directions of groundwater movement. Repair design was developed based on subject investigations. Repair was implemented with continuous monitoring of the effects of installation, on a complex monitoring system, and real-time data processing in the mathematical model results of which were then used to adjust and direct the works. The works were carried out in 2 phases. The inert materials were installed in the first phase, while the consolidation was carried out in the second phase. The total water losses from the reservoir at the end of the repair works were reduced to 3.74 m<sup>3</sup>/s. This paper presents the investigation activities carried out before and during the repair works

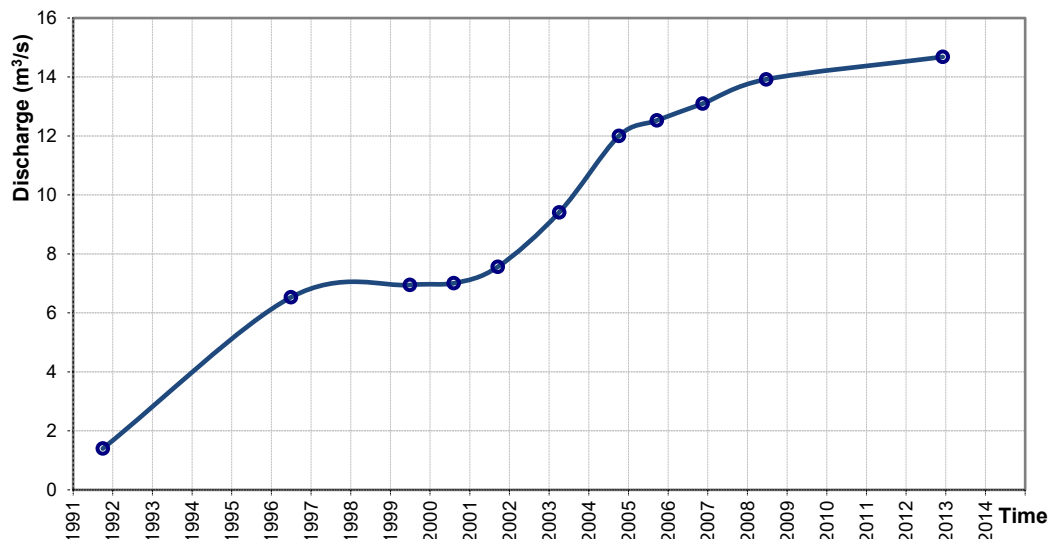
A number of sources occurred on the foundation joint at the beginning of the construction of the HPP Višegrad dam, as early as in the dam foundation excavation phase. The occurrences of numerous sources in the Drina riverbed downstream of the dam were registered during reservoir filling at an elevation of 332.00 masl (4.0 m below the max. elevation). Immediately after the occurrence of seepage, the grout curtain was repaired in the block 5 zone along the width of 30 m and depth of 110 m. This included repair of 48 out of a total of 52 registered water penetrations, but the seepage has not stopped. Despite these works, measurements of the water quantity coming out of the sources downstream of the dam found that the quantity from the original 1.4 m<sup>3</sup>/s (1990) increased up to 14.68 m<sup>3</sup>/s (December 2012) (Figure 2).

Figure 2. Aggregate discharge at the sources in the Drina riverbed

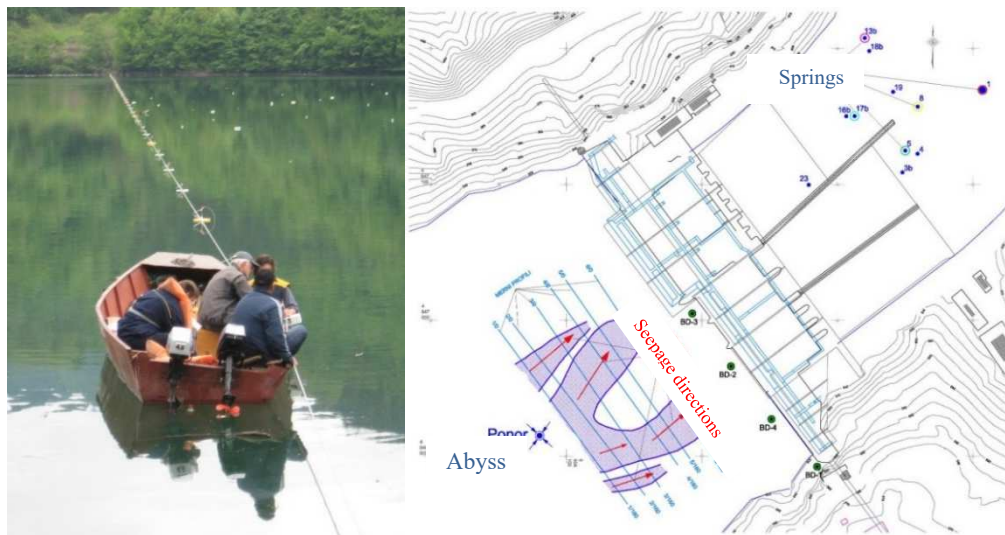
Two significant seepage zones were detected: from the sinkhole to the right, in the direction of block number 5, and to the left, in the direction of the turbine segment of the dam, i.e., block number 9 (Figure 9).

**Figure 9.** Identification of groundwater movement directions in the zone upstream of the dam – geo-electric scanning and "misse a la masse"

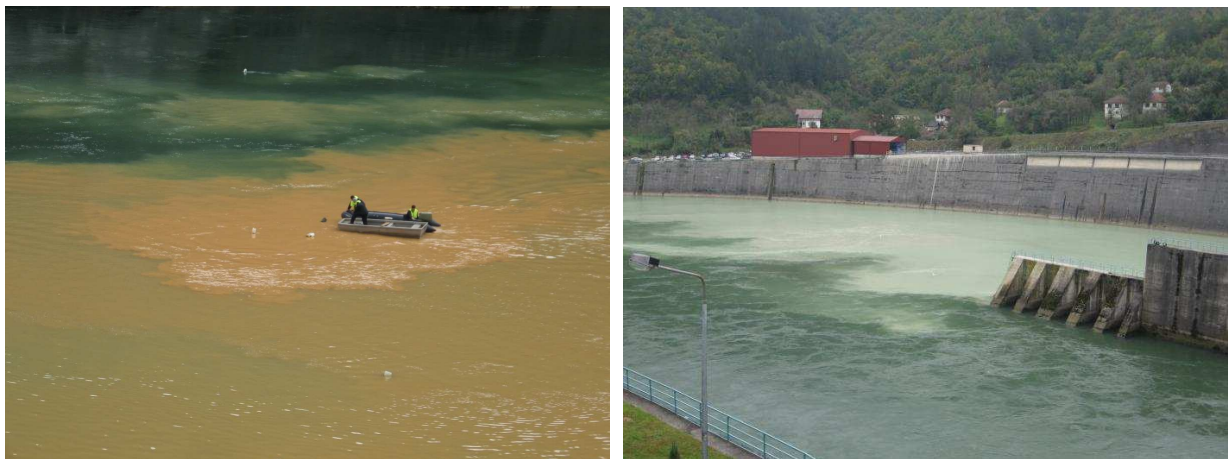
From the downstream side of the dam, material removal was observed at the downstream sources' sites, with a detailed record of the intensity of occurrences and a qualitative assessment of the type of material that was extracted (clay, sand, grouting mass). Sampling of material extracted at downstream sources was also carried out at characteristic moments (Figure 23).

*Figure 23. Visual observation of the source downstream of the dam (removal of clay and grouting mass) and sampling*

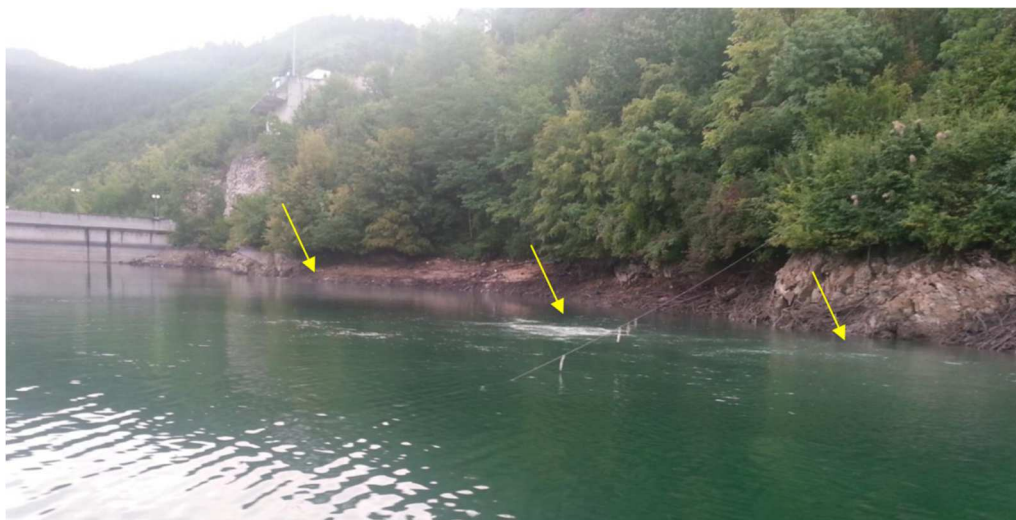
In the reservoir area, within the scope of visual observations, the most significant phenomena observed during the period of repair works were those detected during the airlift of the Great Abyss. A large number of locations were registered at this time where bubbles appeared, in the reservoir zone (Figure 24).

*Figure 24. Air outlet in the right flank of the reservoir zone*

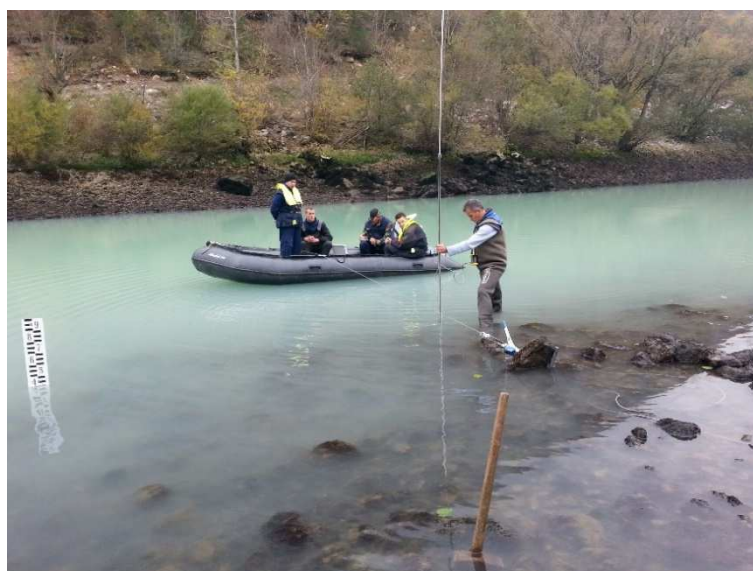
After the repair works were aborted (02/11/2014), hydrometric measurement was performed downstream of the dam with the aim of identifying the effects of repair. The measured seepage under the HPP "Višegrad" dam for the given conditions was 4.47 m<sup>3</sup>/s (Figure 25).

**Figure 25.** Hydrometric measurement of total seepage downstream of the dam

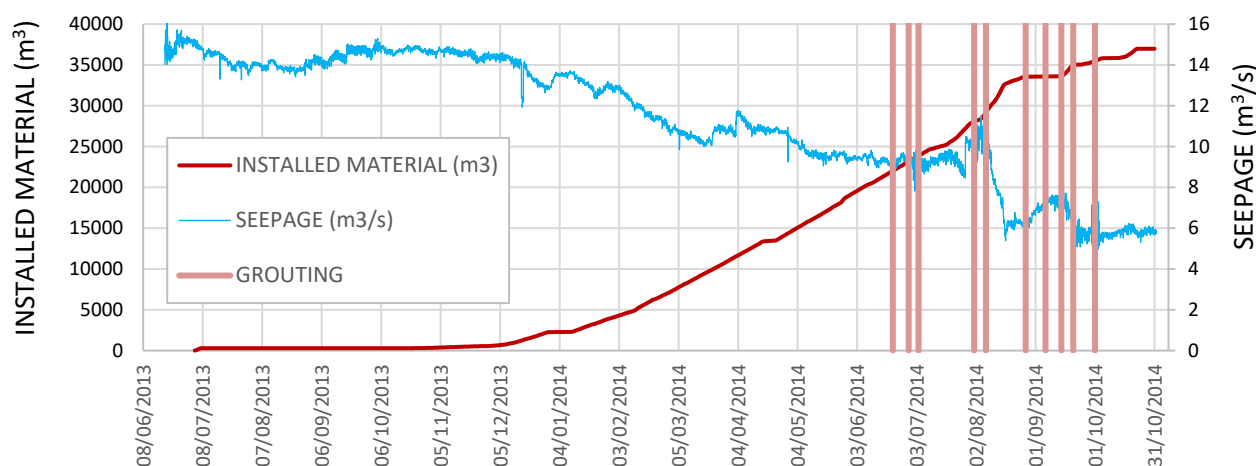
**Figure 32.** Effects of quantities of installed materials and achieved effects (2012-2014 period)

The works carried out within the subject repair have largely achieved the preset goals. The total discharge was reduced from 14.6 m<sup>3</sup>/s to 3.74 m<sup>3</sup>/s (Figure 32). Reduction of seepage under the dam foundation was primarily achieved by installing granular material through the boreholes along the upstream face of the dam.

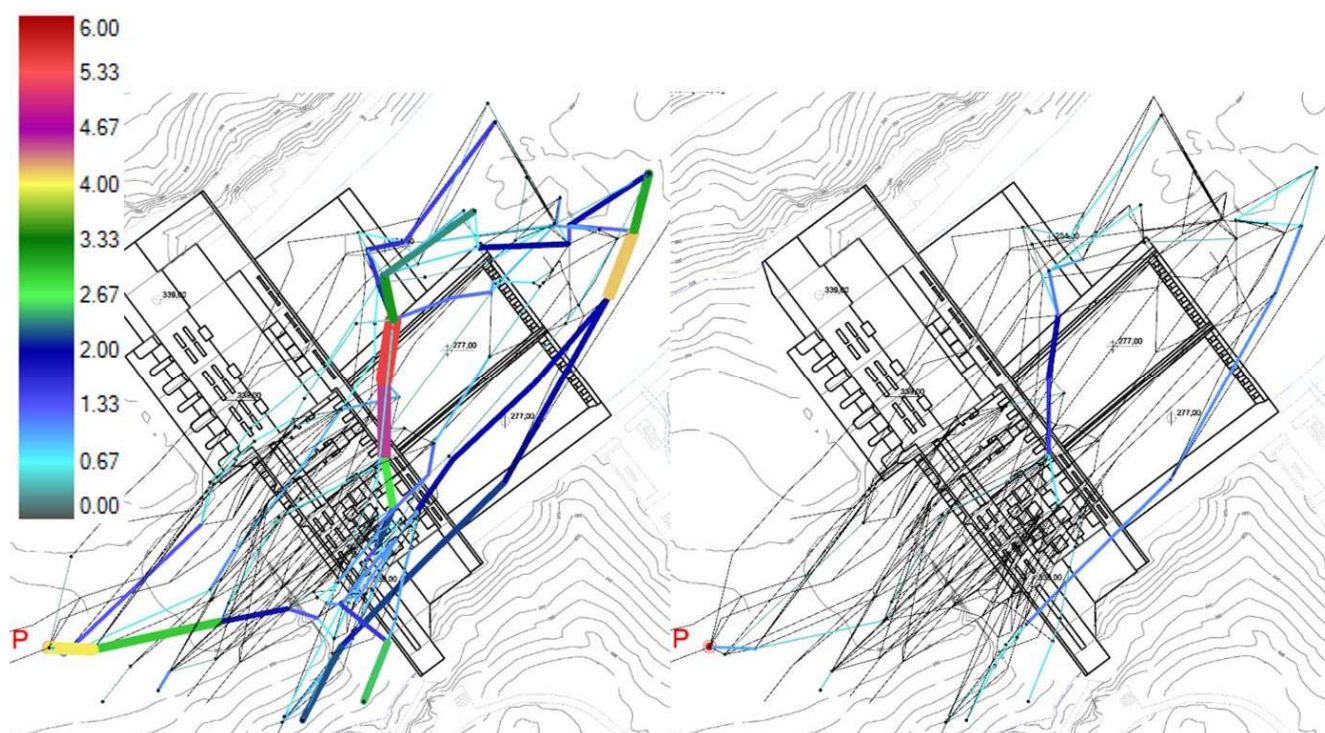
The discharges in the channels were stopped or reduced, in different channels to a different extent. Before the repair, there were several locations in the network with several individual channels with discharges over 2.0 m<sup>3</sup>/s, and the maximum water discharge in the channel was over 5.5 m<sup>3</sup>/s. After the repair works, the biggest discharges were in the same channels in which they were bid before the repair, but they were reduced several times. There were no channels with discharges greater than 1.2 m<sup>3</sup>/s after repair (Figures 33, 34 and 35).

**Figure 33.** Layout of channels with water discharges (m<sup>3</sup>/s) before and after repair

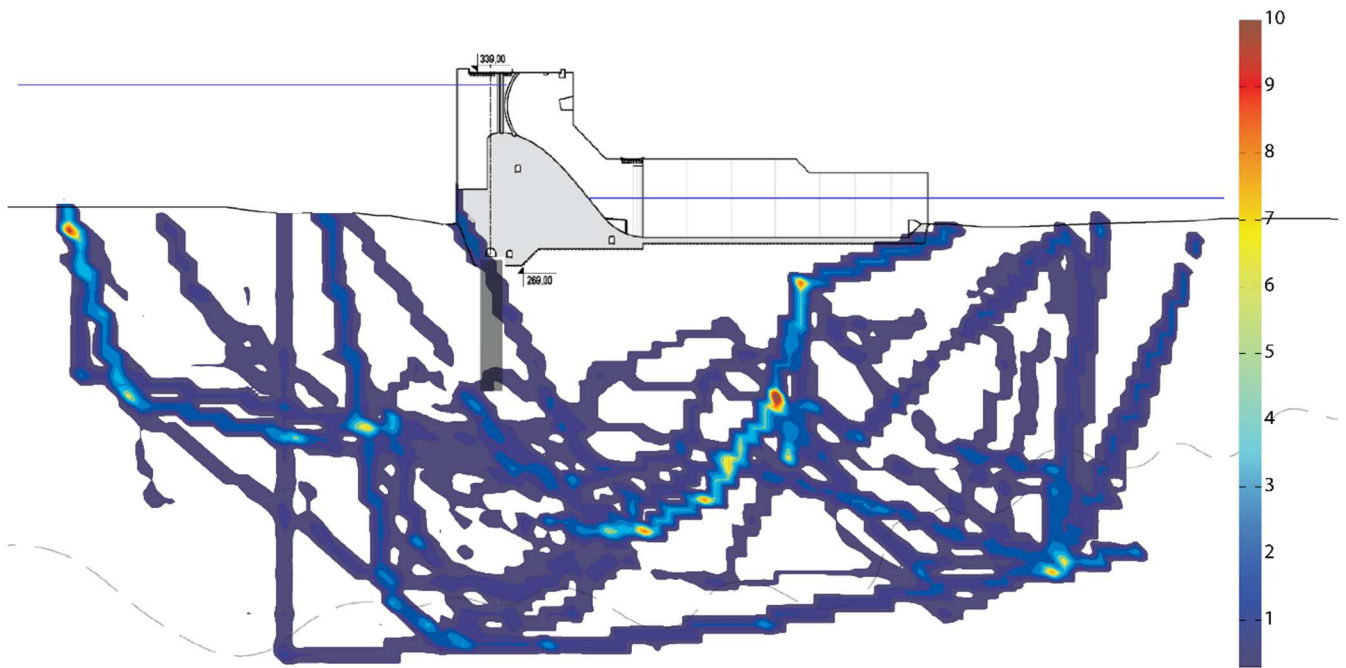
*Figure 34. Sum of water discharges in channels ( $\text{m}^3/\text{s}$ ) before repair*

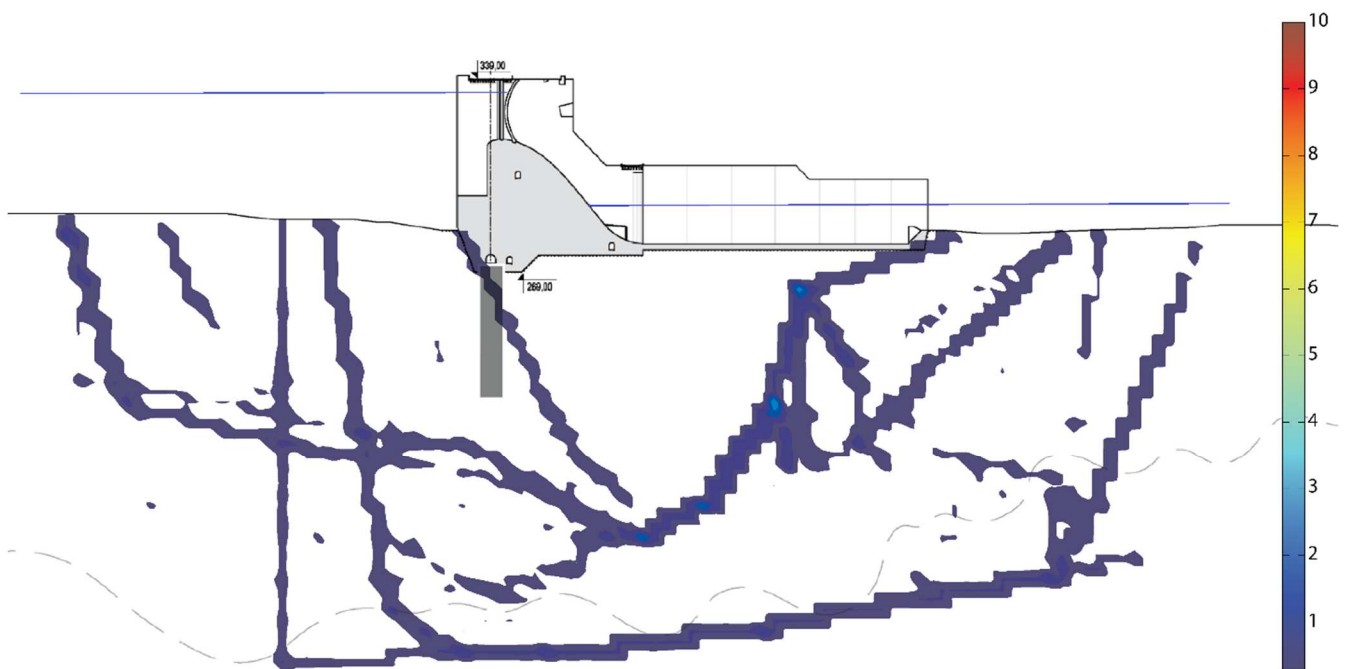
The best effects were achieved in the part of the channel system downstream of the sites where the mass installation was carried out. The most significant installation of granular material in the channel system, i.e., the largest quantities are installed in the channels drilled via the borehole RB-10, then B-15 and less via RB-4 in the channels at the site of the great abyss.

*Figure 35. Sum of water discharges in channels ( $\text{m}^3/\text{s}$ ) after repair*
