## CASE REPORT

# Inappropriate shock delivery as a result of electromagnetic interference originating from the faulty electrical installation

Inappropriate shock delivery as a result of electromagnetic interference originating from the faulty electrical installation.

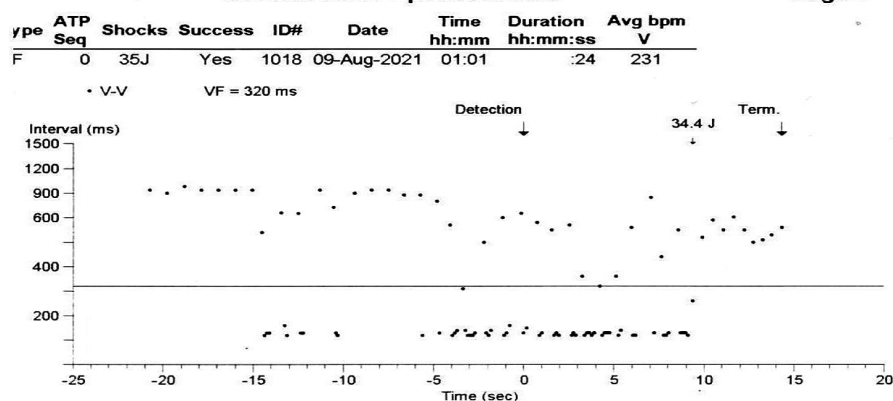
ICD interrogation revealed inappropriate ICD shocks due to electromagnetic interferences during bathing in the tub (Figure 1). The intracardiac electrograms showed a clear sinus rhythm, where R waves are visible and RR intervals were approximately 940 ms. However, at one point the electrocardiogram showed a sudden onset of a 50 Hz electrical artifact mimicking fast ventricular tachycardia which the device misinterpreted as such. The device then delivered a 34.8 joules shock while the patient was actually in sinus

**FIGURE 1** Plot diagram demonstrates typical oversensing pattern, inappropriate VF detection and cessation following the delivery of the shock (due to patient dislocation from EMI source)

After this event, the maintenance workers investigated the electrical installation in the bathroom and found that there indeed was leaking voltage between the electrical installation and the metal pipes. The electrical installations were subsequently repaired and there were no significant changes in the ICD parameters after the event. The patient has not experienced any further ICD shocks, nor ICD noise reversion episodes.

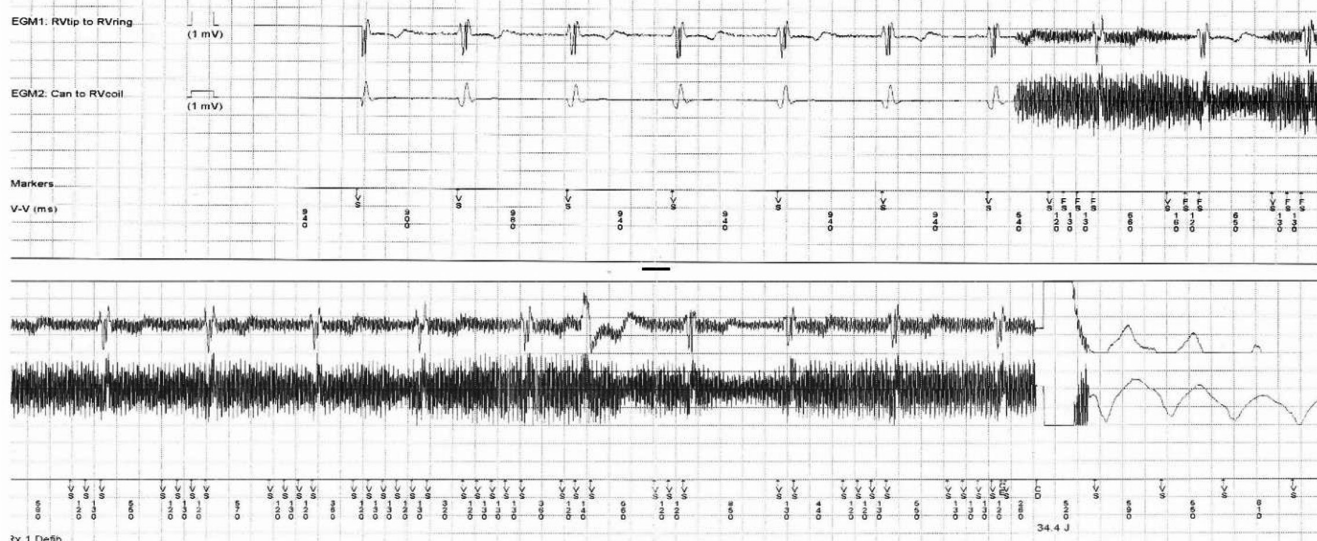
**FIGURE 2** Intracardiac electrocardiogram at 25 mm/second, clearly shows a sinus rhythm with EMI detected as ventricular fibrillation, resulting in delivery of an inappropriate shock. Notice that external EMI usually has lower amplitude on channels recorded from small, closely spaced electrodes ("RV tip to RV ring") than on those recorded from widely spaced electrodes or those that include a large defibrillation electrode ("Can to RV coil")

rhythm. Despite the constant amplitude of the EMI source, oversensing may vary because of automatic adjustment of sensitivity and postural variation in the orientation of the sensing bipole relative to the electric or magnetic field. (Figure 2). The patient was not injured. The ICD function was correct except suboptimal sensing value of 2.4mV to 4mV.
