GEOMECHANICAL TESTING ON THE LANDSLIDE AT THE ČUKARU PEKI FLOTATION TAILING DUMP***

During formation of the flotation tailing dump Čukaru Peki, a landslide was activated above the mentioned location, which led to a standstill and endangerment of works. In order to obtain the geotechnical bases for designing the measures for its rehabilitation, the landslide tests were performed. Geomechanical works included the field research and testing, laboratory geomechanical testing and cabinet work.

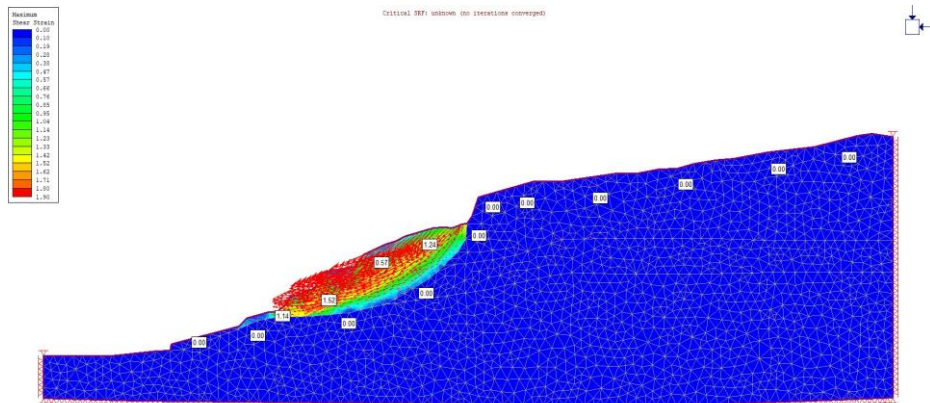
Figure 2.5 shows the maximum shear deformations of sliding material.

Figure 2.5 Maximum shear deformations of sliding material
