Ljubiša Obradović^{*1}, Sandra Milutinović^{*2}, Srdana Magdalinović^{*3}, Sanja Petrović^{*4}

INTEGRATED DISPOSAL OF MINING WASTE, AN EXAMPLE OF REHABILITATION THE DAMAGED EMBANKMENT AT THE RTH TAILING DUMP BY THE MINE OVERBURDEN**

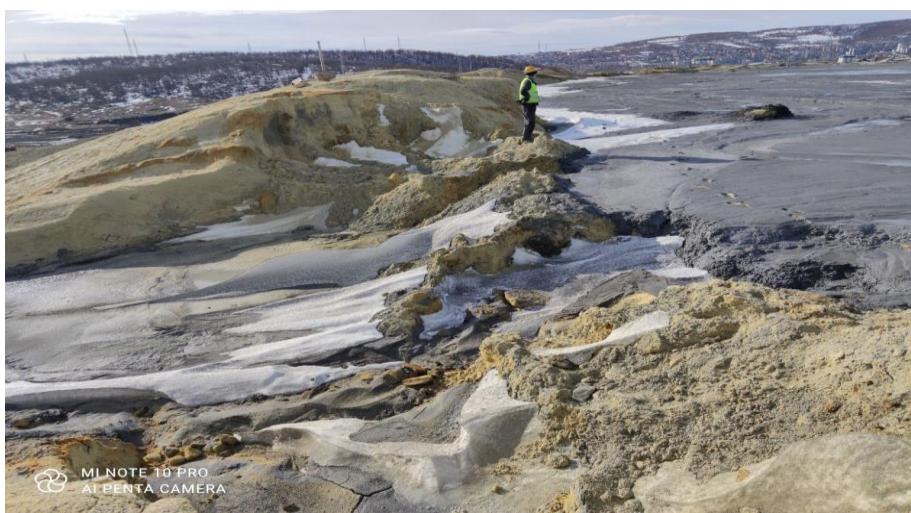
Figure 3 shows the part of Dam 2 where, due to erosion, the first overflow of water and sludge occurred over dam 2 into the surrounding area on 01/29/2021. year, which could have caused very serious problems at the flotation tailing dump. The quick response of employees at the tailing dump stopped the overflow of sludge, which was quickly localized and stopped. This part of embankment is highly

threatened by the wind erosion, and here the urgent interventions are necessary in terms of correcting the geometry of embankment in accordance with the current technological project, in order to prevent the harmful consequences that further erosion of the embankment can cause for the stability of this part of embankment, as well as the entire RTH flotation tailing dump as a unique mining object [5].

Figure 3 Completely eroded crown of the Dam 2 where the first serious overflows of water and sludge were observed over the crown and downstream slope, January 29, 2021

In order to rehabilitate the crowns of the dams and embankments at the flotation tailing dump and bring their geometry to the designed geometry, the Investor concluded a contract with MMI Bor for development the SMD for overhanging the flotation tai-

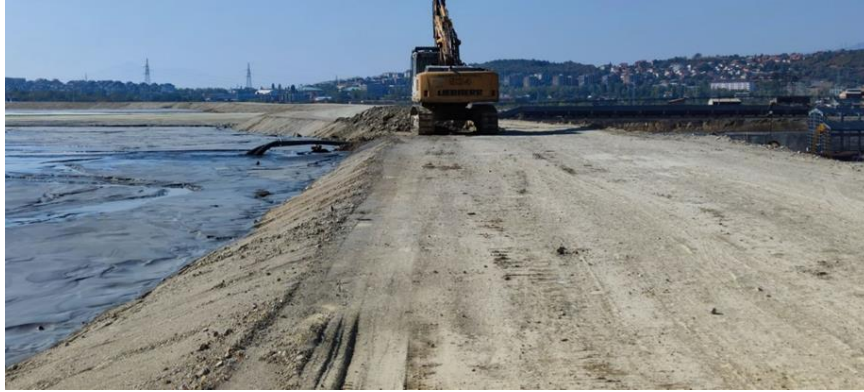
Figure 5 Embankment between the Dam 2 and high landfill, October 5, 2021

During the summer and autumn of 2021, the rehabilitation works were carried out on the field, after the works on the crown of the dam and geometry of the embankment at the tailing dump, a stable condition was brought in accordance with the valid Technological design. The crowns and embankments after the rehabilitation works are present in Figures 5 and 6.

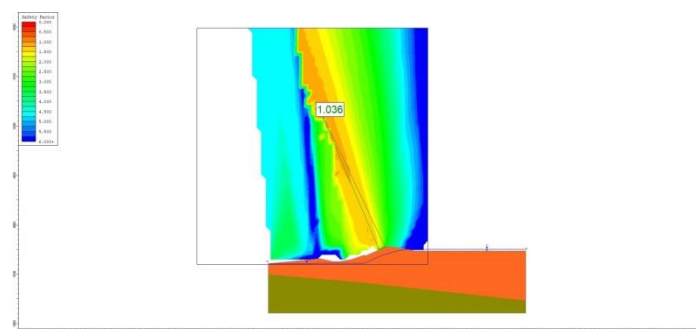
The stability calculation, according to the analysis profile for the constant static loads and dynamic loads for the seismicity coefficient $KS = 0.13$, is shown in Figures 7 and 8 for the profile 4 before rehabilitation [1]. The stability calculation after rehabilitation of the embankment is shown in Figures 9 and 10, while the calculation results are shown in Table 5.

Profile	F_s static	F_s dynamic
Before rehabilitation		
4	1.036	0.783
After rehabilitation		
4	2.115	1.696

Figure 7 Stability coefficient according to the profile 4 for static loads, Yanbu method

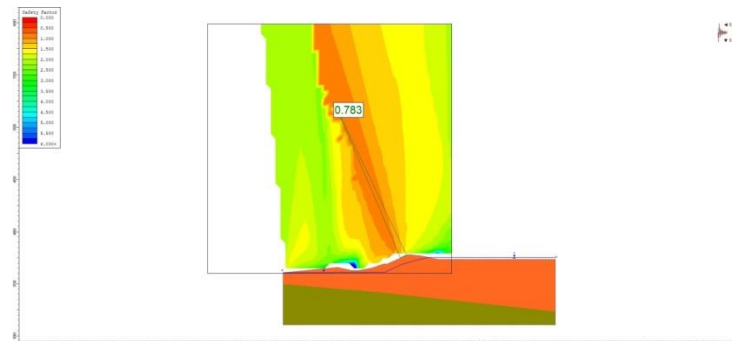
Figure 8 Stability coefficient according to the profile 4 for dynamic loads, Yanbu method

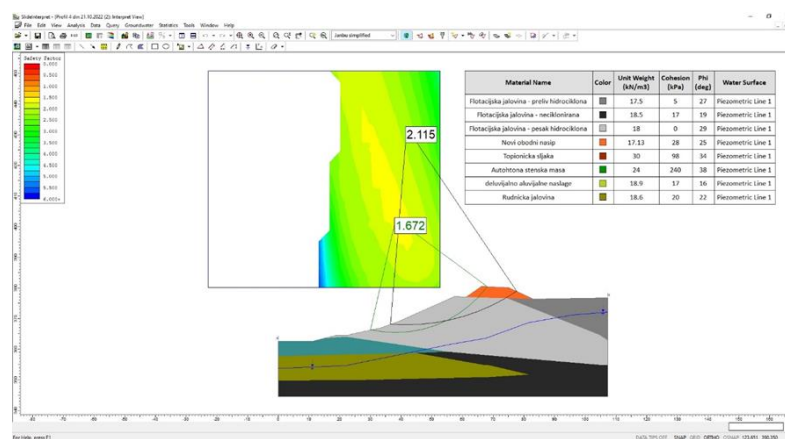
Figure 9 Stability coefficient according to the profile 4 for dynamic loads, Yanbu method

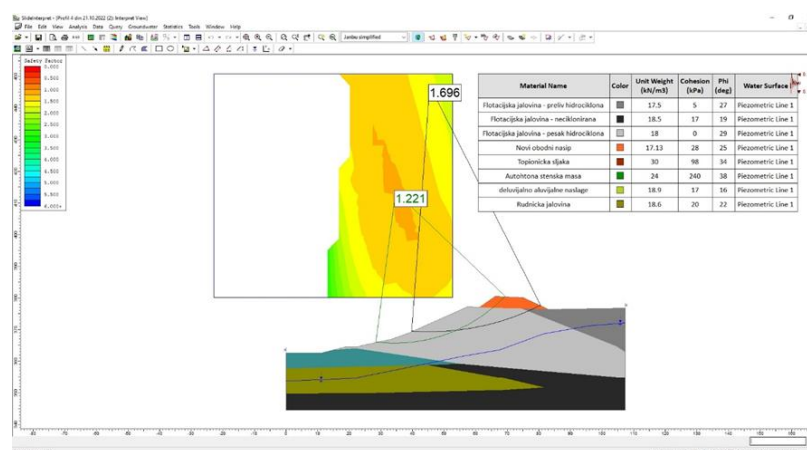
Figure 10 Stability coefficient according to the profile 4 for dynamic loads after embankment rehabilitation, the Yanbu method

By comparison the safety coefficients of the flotation tailing dam with permitted minimum coefficients, according to the valid standard for dams (SRPS U.C5.020), which for the embanked dams over 15 m in height is a minimum of $F_s = 1.50$ in case of permanent static load, i.e., $F_s = 1.00$ in the case of an occasional dynamic load for the occurrence of an earthquake, it can be concluded that for the profile 4 after rehabilitation, the values for both coefficients (for the static and dynamic loads) are more than doubled, i.e., significantly above the prescribed minimums.
