Mining and Metallurgy Engineering Bor

2/2022

REHABILITATION OF THE LANDSLIDE AT THE "LANDFILL 3" IN THE ZONE OF THE ČUKARU PEKI FLOTATION TAILING DUMP**

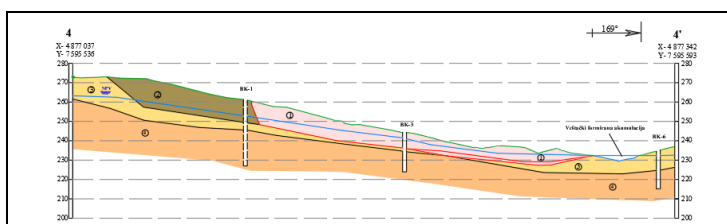
Figure 2 Characteristic geotechnical profile

It is assumed that the thickness of the activated material in the central part is up to 23 m. By mapping the field, a frontal scar visible along its entire length was observed, with a jump of an average of 2 m, with a clearly visible plane along which the movement occurred. The deposited material and part of deluvial clays were affected by sliding.

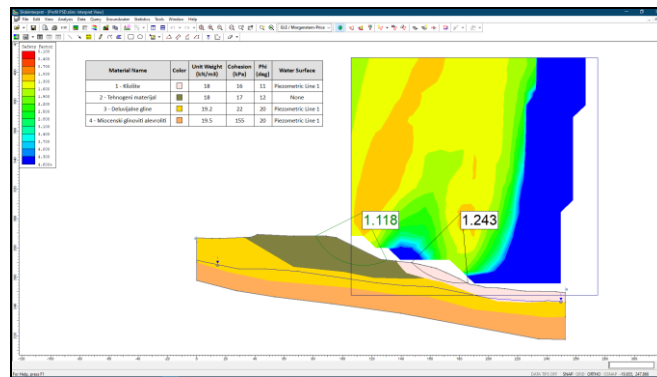
Figure 5 Calculation the existing landfill state stability in the Slide program

Analyzing the calculation results of the existing state stability of the landfill, the areas were determined where the safety coefficient is below the legal minimum [3]. The values of safety coefficients of

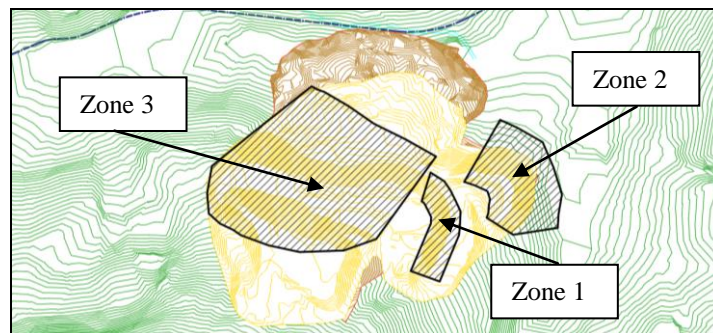
the existing state confirm that rehabilitation of certain parts of the landfill is required. Figure 6 shows the areas of "Landfill 3" that require rehabilitation.

Figure 6 Rehabilitation areas of the "Landfill 3"

Rehabilitation of the landfill critical areas will be carried out by transferring the dumped material from higher elevations towards the base of the landfill, whereby the slope angles will be softened as much as is necessary to satisfy the legal minimum for the stability condition [3].

The material transferred to the foot of the landfill is ballast, which has a positive effect on stability. Work on transferring the deposited material from higher elevations towards the base of the landfill will be done with bulldozers.

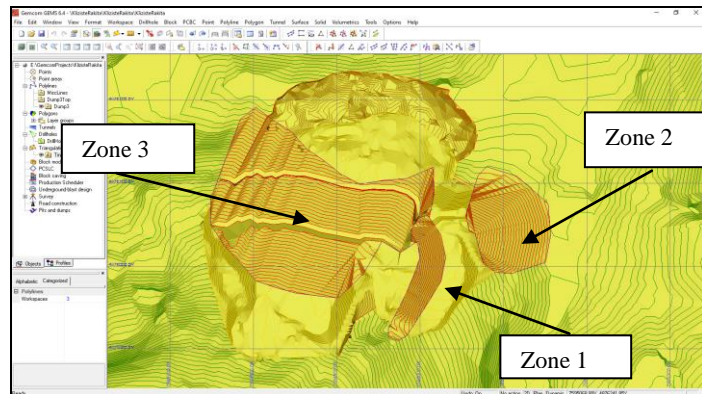
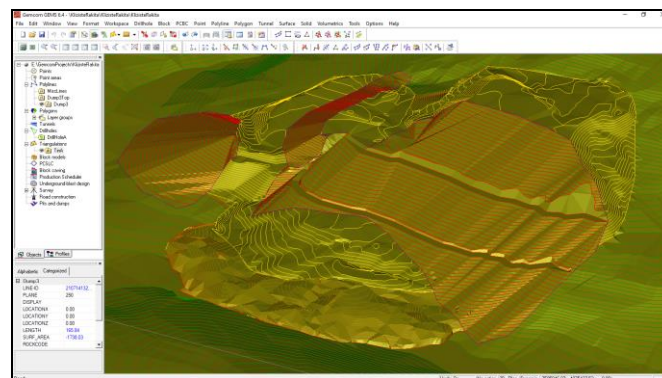
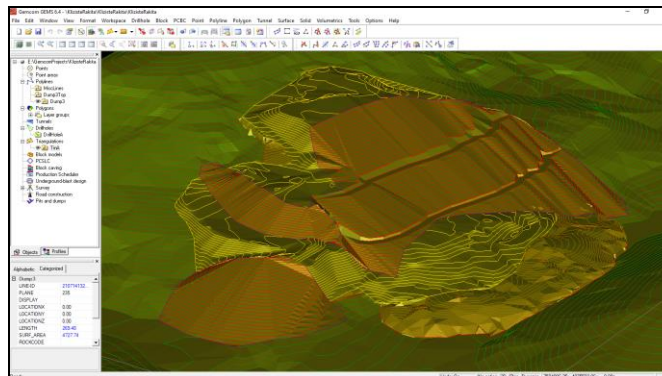
Figure 7 2D view of the field and landfill model after rehabilitation

Figure 8 3D model of the rehabilitated landfill - view from the northwest

Figure 9 3D model of the rehabilitated landfill - view from the northeast

The general angle of slope of the rehabilitated zone 1 is 24°. The general slope angle of the rehabilitated zone 2 is 18°. The general angle of slope of the rehabilitated zone 3 is 14°.

In order to protect the local road whose route passes under rehabilitation zone 3, two bench levels will be built at the levels k+267 m and k+252 m, Figures 7 - 9.

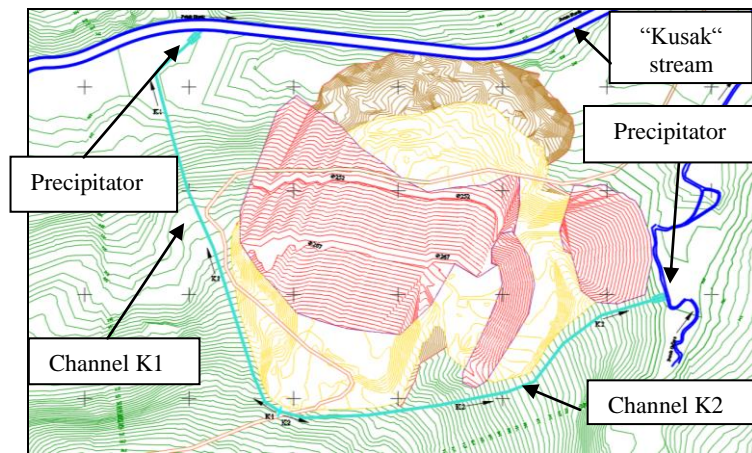
Figure 10 Location of the drainage channel

gravitates during atmospheric precipitation, the construction of two channels with sedimentation tanks for settling the solid particles before discharge into natural water-courses is planned: the first channel from the western side of the landfill and the second channel from the southern side of the landfill, Figure 10. Water from both channels, they are taken to a sedimentation tank, from where, after solid particles have settled, they are discharged into the "Kusak" stream.

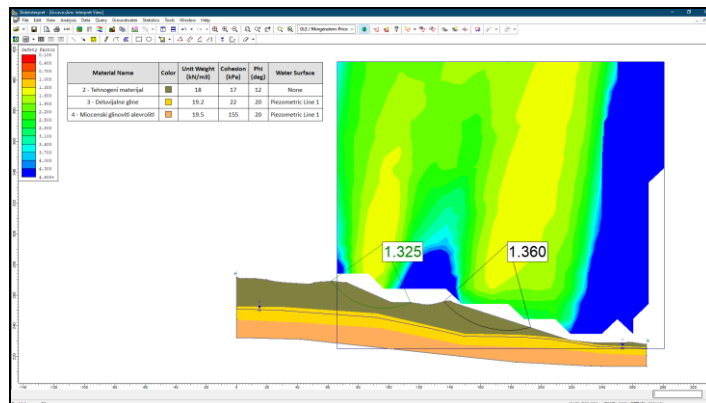
Figure 11 Stability calculation of the rehabilitated landfill in the Slide program

Analyzing the calculation results of the landfill stability after rehabilitation, the conclusion is that the legal minimum value of the stability coefficient of $F_s = 1.30$ for soft rocks on the landfill is met [3].
