SHAPING THE FUTURE OF TUNNELLING
Innovation, Sustainability and Safety

PROCEEDINGS OF THE SOUTHEASTERN EUROPE TUNNELLING CONFERENCE (SETC-2025)

This paper initially presents a description of the facility and its condition immediately prior to the rehabilitation, with particular emphasis on the hydraulic tunnel. The core focus is on the presentation of the rehabilitation technology and execution, which involved pressure grouting, the installation of prestressed rock anchors and chemical grouting. The paper discusses the results and challenges encountered during the rehabilitation process, offering a critical analysis aimed at emphasizing the significance of rehabilitation works and encouraging the exchange of experience in the restoration of capital infrastructure with extended service life.

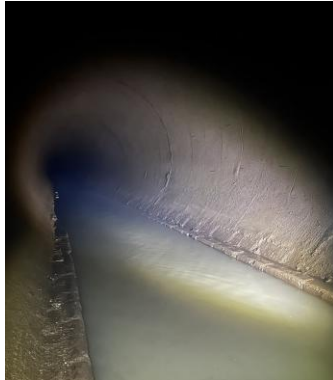
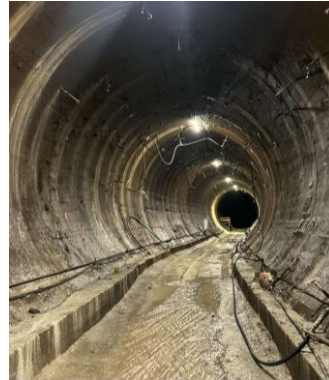
Fig.1. (a) Map of Serbia showing the River Drina and the position of the PSHP Bajina Bašta (Radovanović et al., 2022), (b), (c) Hydrotechnical Tunnel of the Reversible Hydroelectric Power Plant “Bajina Bašta”.

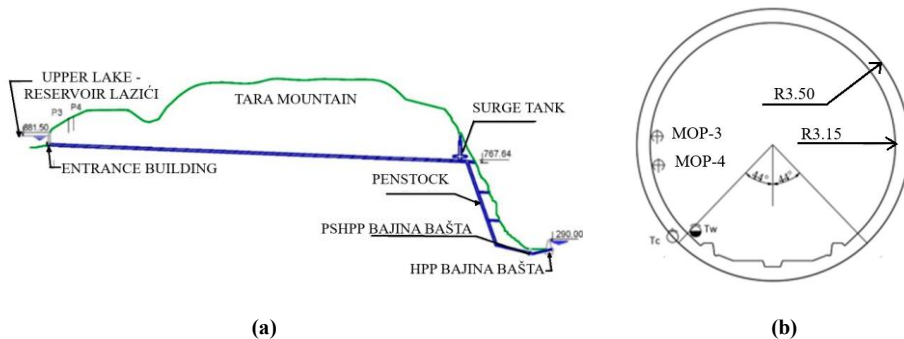
The tunnel in question has a circular cross-section with a diameter of 6.30 meters. Its total length is 8030 meters, with a longitudinal slope of 4.5‰. This tunnel belongs to the category of pressurized hydrotechnical tunnels, in which, under operational conditions, a maximum hydrostatic pressure of 1.3 MPa occurs (Ai et al., 2020).

Fig. 2. (a) Longitudinal tunnel profile with a schematic view of the upper lake, pipeline, PSHPP and HPP “Bajina Bašta”, (b) Cross-section of tunnel (Radovanović et al., 2022).

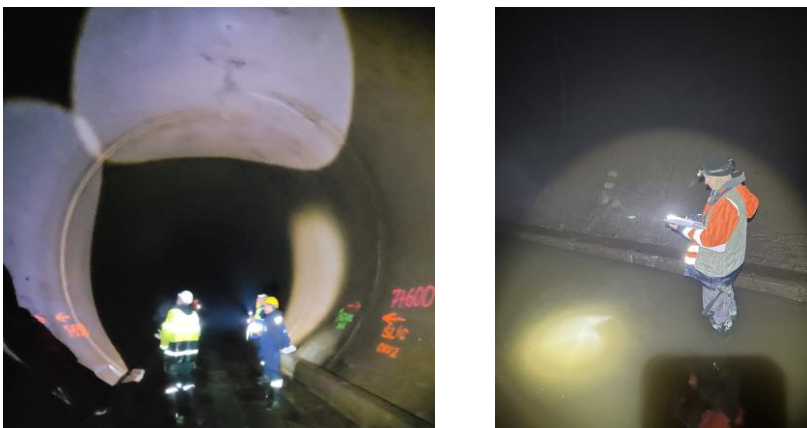
Following dewatering of the tunnel, the initial activity conducted in the hydrotechnical tunnel was a visual inspection, which, as similarly described in Krukovskiy et al., (2024), included the preparation of graphical documentation for mapping cracks in the concrete lining. The main objective of the visual inspection was to either confirm or adjust the proposed rehabilitation design, in case certain areas – originally not included in the project – were found to be in a critical condition. As part of project implementation, two visual inspections were performed: the first prior to the commencement of reconstruction works, the second upon completion of all works, to assess the effectiveness of the interventions with respect to the project specifications.

Fig. 3. Visual Inspection – Mapping of Changes in Concrete Lining.

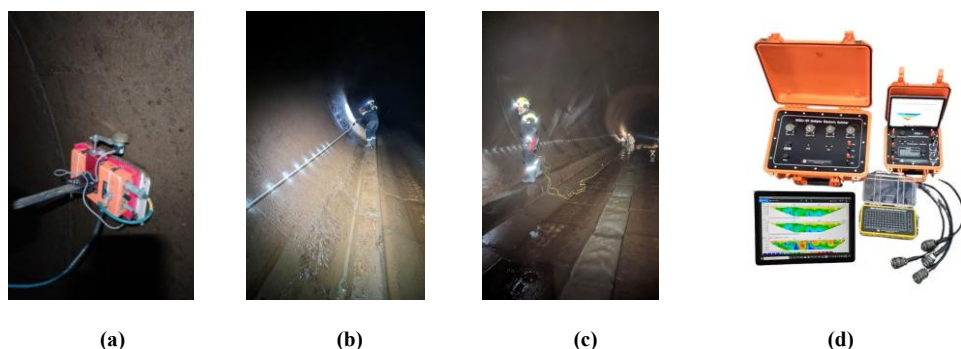
The geophysical investigations of the concrete lining of the HTT were performed using ground penetrating radar (GPR) and electrical resistivity imaging (ERI) methods. The objective of these investigations was to assess the condition of the tunnel lining and the surrounding rock mass in direct contact with the concrete lining, focusing on crack patterns, water flow paths in both vertical and horizontal planes, and the presence of cavities and voids behind the concrete lining.

Fig. 4. Geoelectric Testing: (a) Ground Penetrating Radar (GPR); (b), (c) Preparation for Geoelectric Measurements – Placement of Metal Electrodes; (d) Geoelectric Measurement System – VS-1 Resistivity Meter, Electrode Selector, External Power Module and Cables with Metal Electrodes.

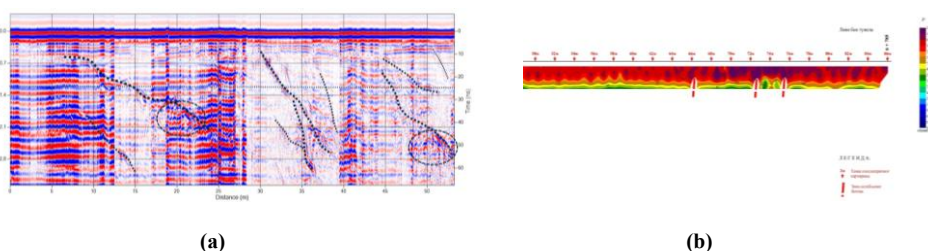
Following the completion of the rehabilitation works, the application of this type of investigation enabled verification and quality control of the implemented remedial measures. In the case of this specific project, a total of 7,000 m³ of ground penetrating radar (GPR) surveys and 175 m³ of electrical resistivity imaging (ERI) surveys were performed.

Fig.5. Geoelectric Testing: (a) Results of Ground Penetrating Radar (GPR) Surveys; (b) Results of Geoelectric Measurements.

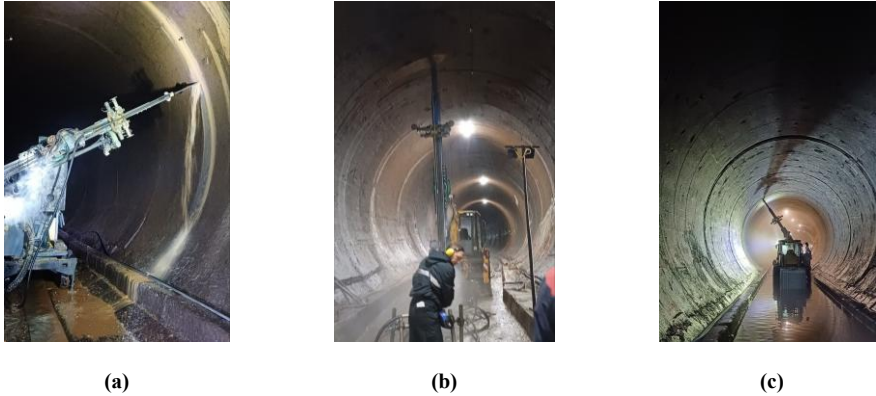
The works were carried out at predefined locations along nearly the entire alignment of the tunnel, starting with machine drilling using rotary-percussive drilling with water cooling. The equipment used included the Hydra Joy 2P drill rig, equipped with a hydraulic hammer.

The drilling procedure differed only in two areas: within the surge shaft and at the very beginning of the tunnel, in the bifurcation zone. In the surge shaft, drilling was performed manually using pneumatic hand drills, while in the bifurcation zone and the initial tunnel stations, a Hydra SL200 hydraulic hammer mounted on a JCB 3CX skip loader was used to ensure better mobility and maneuverability.

Fig. 6. (a) Hydra Joy 2P equipped with a hydraulic hammer; (b), (c) Hydraulic hammer Hydra SL200 mounted on the JCB 3CX skip carrier.

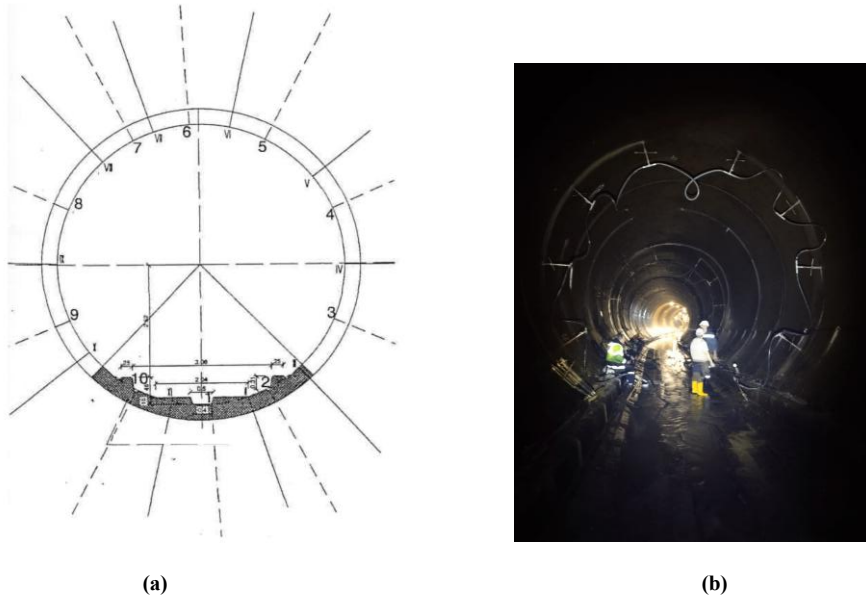
Drilling was executed in a radial pattern, as specified by the design, with 5-meter spacing between boreholes, a drilling depth of 4 meters, and a borehole diameter of $\text{Ø}56$ mm. The design also included a provision for modifying the technical solution in the event of increased grout consumption – specifically, by reducing the radial spacing between boreholes to 2.5 meters.

Fig. 7. (a) Detail of stress grouting according to the rehabilitation project; (b) Drilling execution inside the tunnel.

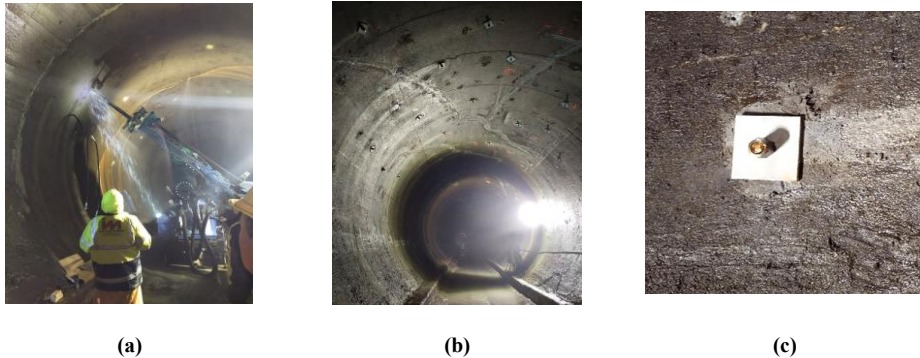
The rehabilitation project specified the installation of self-drilling anchors (SDAs). The maximum designed anchor length was $L = 6$ m (Type 3), while in certain locations, shorter anchors were prescribed: $L = 3$ m (Type 1) and $L = 4$ m (Type 2).

The installation procedure was the same for all SDA types. Prior to installation, $\varnothing 56$ mm boreholes were drilled to the required depth, using the same equipment as for the stress grouting works.

Fig. 8. (a) Drilling of tunnel lining, (b) Appearance of tunnel lining after installation of anchors, (c) Anchor type “SDA”.

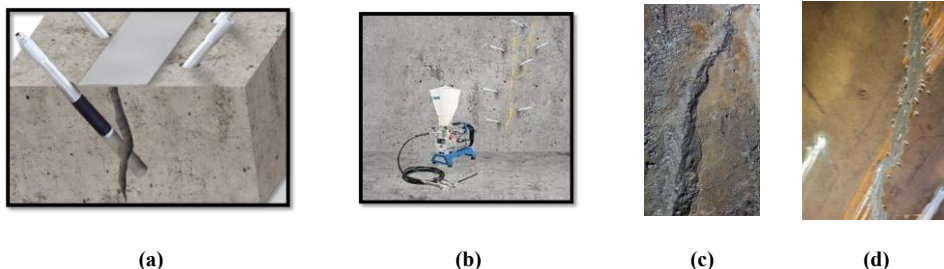
Chemical grouting was performed using polyurethane-based injection materials. To prevent leakage of the injection grout, the cracks were prepared by cutting triangular grooves along their length. These grooves measured $3\text{ cm} \times 3\text{ cm}$ and were filled with fast-setting mortar prior to injection.

Drill holes were made at an angle of 45° , diagonally across the crack, with spacing between 25 and 35 cm, resulting in borehole lengths ranging from 45 to 55 cm, placed alternately on both sides of the crack (left and right). Drilling was performed mechanically, using electric drills with a borehole diameter of $\varnothing 10$ mm. Upon completion of the chemical grouting process – i.e., after the polyurethane material had cured – the packer was removed and the borehole was sealed with mortar.

Fig. 9. (a) Placement of packer; (b) Overview of complete chemical injection; (c) Saw-cutting of crack; (d) Completed chemical injection

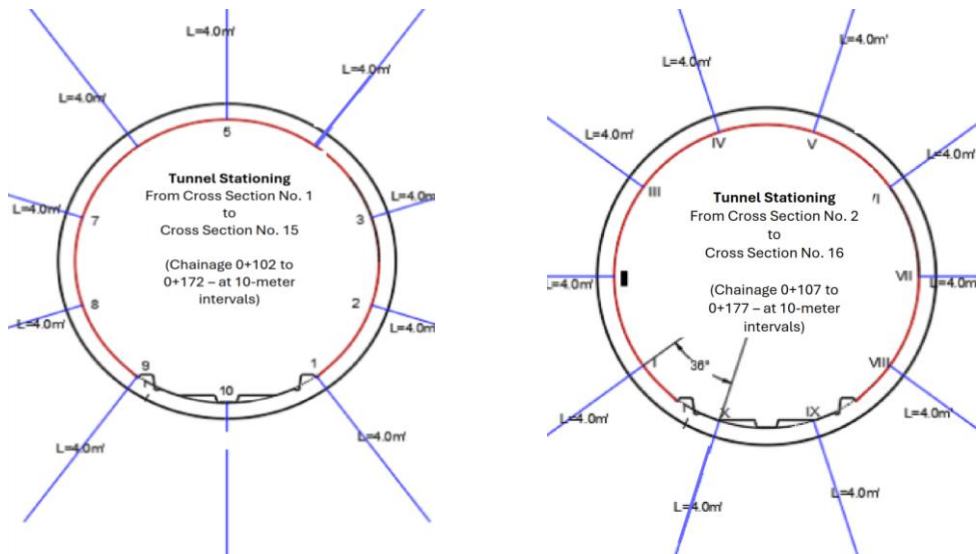
On the left side of Figure 11, the odd-numbered profiles (cross-sections 1 to 15) are shown, while the right side displays the even-numbered profiles (cross-sections 2 to 16). The rehabilitation works were carried out so that the borehole layout within all even profiles is identical, as well as within all odd profiles. However, the borehole arrangements in even profiles differ from those in odd profiles, with boreholes in consecutive profiles offset by an angle of 18°. The spacing between injection profiles is 5 meters.

Fig. 11. Layout of tension grouting injection boreholes (profiles at Work Site 1).

To improve the tunnel's operational conditions, the previously planned pre-stressing grouting at Work Site 1, originally designated for the section from chainage 0+500 to 0+580, was shifted to the section between chainage km 0+100 and 0+180. This created a unified rehabilitation zone from chainage 0+010 to 0+180 to reduce tensile stresses in the concrete caused by water pressure, which will also decrease water losses in the downstream slope area, thus enhancing its stability (Figure 11).

Considering the pressure values during grouting in the empty tunnel, the pressure-induced stresses in the concrete lining depend on the pressure intensity, tunnel diameter, and lining thickness. The project assessment concluded that the maximum grouting pressure should not exceed 20 bar to keep the concrete stresses within allowable limits.

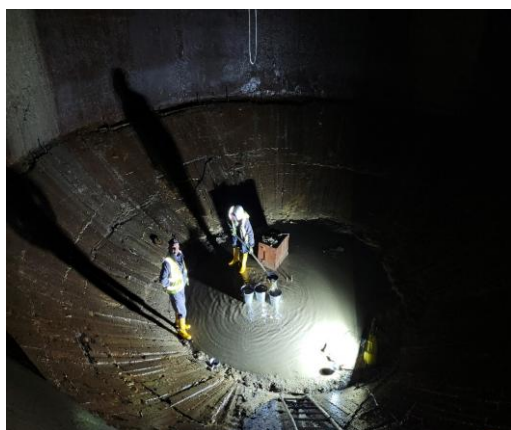
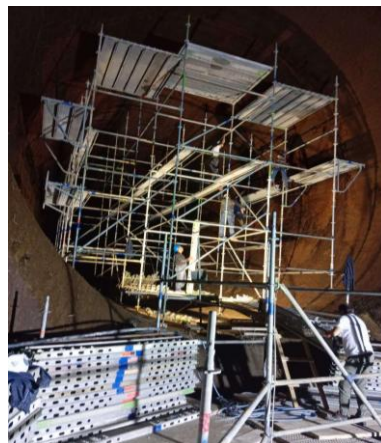
During the execution of the works, monitoring of cracks in the surrounding concrete lining of the lower vault of the surge chamber was conducted, and no changes indicating deficiencies in the execution of the rehabilitation works were observed.

Fig. 13. (a) Mapping of cracks in the concrete lining of the lower crown of the water reservoir, (b) Assembly of scaffolding in the water reservoir chamber

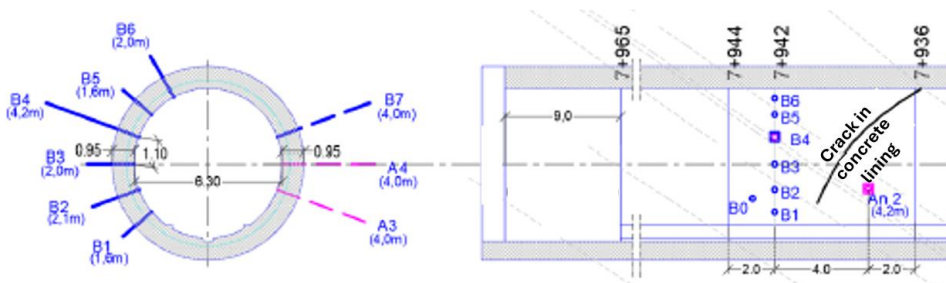
The rehabilitation works began according to the project design by drilling holes and installing SDA anchors shown in Figure 14, marked as B4 and An2. During the drilling for the installation of anchor A2 at a depth of 4 m, water inflow was registered in the borehole with slight leakage. The anchor was installed, but injection grouting could not be performed.

During the drilling for the installation of the anchor marked B4 at a depth of 4.2 m, significant water leakage was registered from the borehole, which, unlike the previous situation, prevented the installation of the anchor. At this position, a packer was installed with a valve at its end, and on the other side, a pressure gauge was mounted, which recorded a pressure of 7.5 bar.

Drilling started at the location marked B0, but after drilling through the concrete lining at a depth of 0.65 m, metal (from reinforcement or straps) was encountered, so further drilling was abandoned and drilling continued below the initial borehole B4. In the zone of borehole B4 at chainage 7+942 on the vertical profile, 5 boreholes of various depths were drilled, as shown in Figure 14. They were drilled at mutual distances of about 1.1 m. Drilling was carried out sequentially, starting with drilling to a depth of 0.6 m. At this depth, the drill string was withdrawn to check for water inflows from the surrounding rock. This procedure was then repeated every 0.3 – 0.5 m until the final depths were reached. The relevant criterion for completion was to drill until water appeared indicating the presence of a discontinuity that needed to be injected. The decision was made not to drill deeper than 2.2 m to avoid entering the zone of reduced effectiveness of previous injections, where larger water inflows under a pressure of 7.5 bar were observed in the cracks.

Fig. 14. Overview of initial anchor installation and grouting works in the section from chainage km 7+944 to 7+936.

In accordance with the condition of the lining at the location, the project design, and the observed phenomena, an additional 5 injection boreholes were drilled at the site to reliably locate water-filled cracks behind the concrete lining, determine pressures, and collect data for the successful execution of further rehabilitation works.

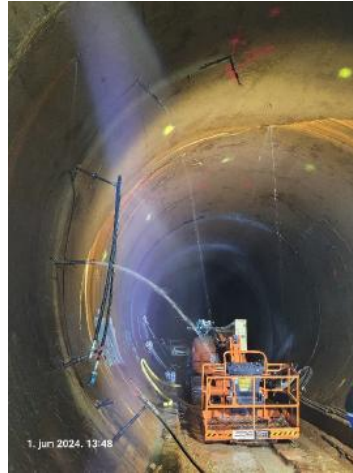
Fig. 15. Installed packers in the right side of the tunnel cross-section at chainage km 7+942.

Due to site conditions, which involved significant risks of water leakage under full pressure from the “Beli Rzav” reservoir, on-site decisions were made that required corrections to the project. The holes for installing 6 m long anchors, as originally planned for this section, were replaced with the installation of 4 m long anchors. At positions where installation of 4 m anchors was not possible due to large water inflows from the borehole, borehole grouting was performed. The proximity of the reservoir and the objective conditions during the work execution meant that, out of the total 177 planned SDA anchors, only 8 were installed at the specified work site (Work Site 4).
