International Conference
**Synergy of
Architecture &
Civil Engineering**

PROCEEDINGS

INVESTIGATIVE WORKS TO DETERMINE THE NATURE OF CRACKS IN THE INTAKE TOWER OF THE ĆELIJE DAM

Key words: Ćelije Dam, Intake Tower, Cracks, Investigative Works, Technical Monitoring

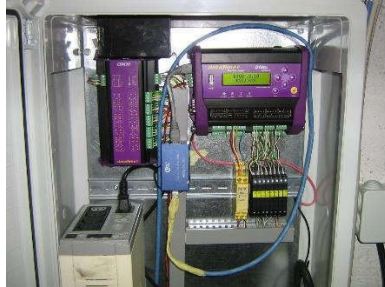
Automatic and telemetry-based data acquisition on the installed instruments is carried out using a special data acquisition system, the central part of which is a data logger with an appropriate extension in the form of a twenty-channel multiplexer, allowing the connection of all existing electrical instruments in the observation system (Figure 7.).

Figure 7. Layout of the measurement cabinet with data logger and accompanying equipment

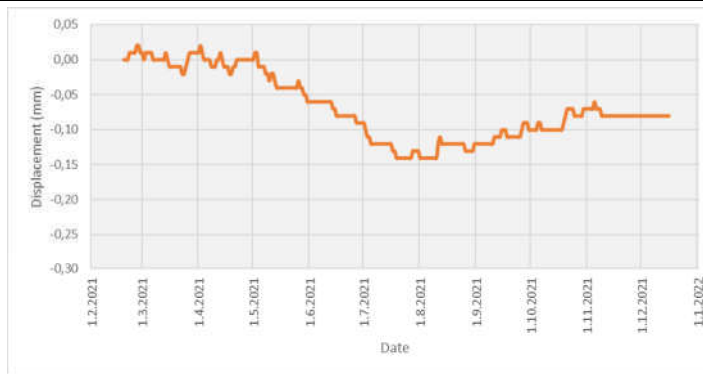
The results of measuring the crack opening indicate cyclic deformations of the intake tower. The measured change in the opening is consistent with the results of the cylinder convergence measurements, meaning that the reduction in the crack opening coincides with the expansion of the tower's cylindrical contour. Positive values in the diagrams below refer to the upward movement of the right end of the crack relative to the left (D-4R, Figure 10.), the opening of the crack (D-4T, Figure 11.), and the lifting of the right end of the crack relative to the left (D-4V, Figure 12.).

Figure 11. The diagram of crack behavior (deformer D-4T)

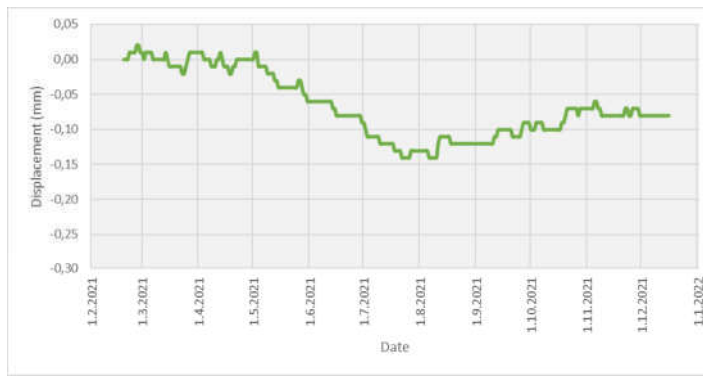
Figure 12. The diagram of crack behavior (deformer D-4V)
