## Remediation of the HPP "Višegrad" Dam

Dejan Divac, Dušan Mikavica, Zoran Dankov, Maja Pavić, Rajko Vasić

**Abstract:** The hydropower plant "Višegrad" is located on the Drina River upstream of Višegrad. Many seepage occurrences have been observed since the construction. Over time, the measured quantities of seepage water under the dam body increased significantly: from 1.4 m<sup>3</sup>/s (1990) to 14.68 m<sup>3</sup>/s (2012). Investigations were implemented during 2008-2009 period to define the directions of groundwater movement. Repair design was developed based on subject investigations. Repair was implemented with continuous monitoring of the effects of installation, on a complex monitoring system, and real-time data processing in the mathematical model results of which were then used to adjust and direct the works. The works were carried out in 2 phases. The inert materials were installed in the first phase, while the consolidation was carried out in the second phase. The total water losses from the reservoir at the end of the repair works were reduced to 3.74 m<sup>3</sup>/s. This paper presents the investigation activities carried out before and during the repair works

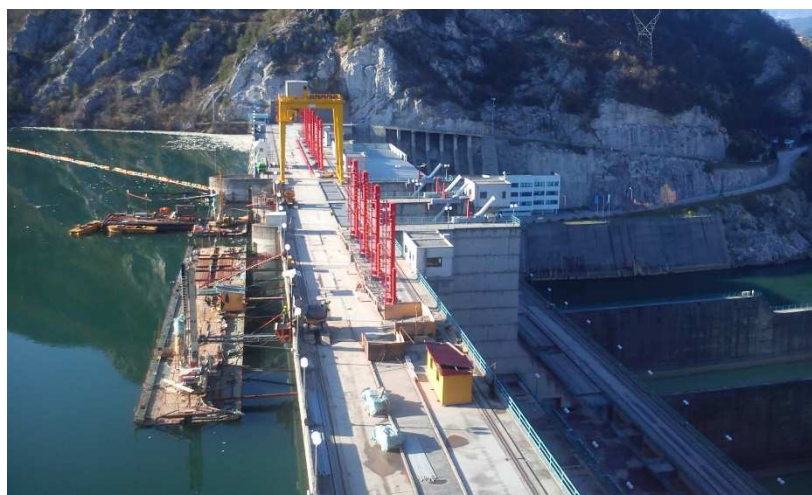
**Figure 1.** HPP Višegrad Dam (with a working platform where the repair works were carried out in 2016)

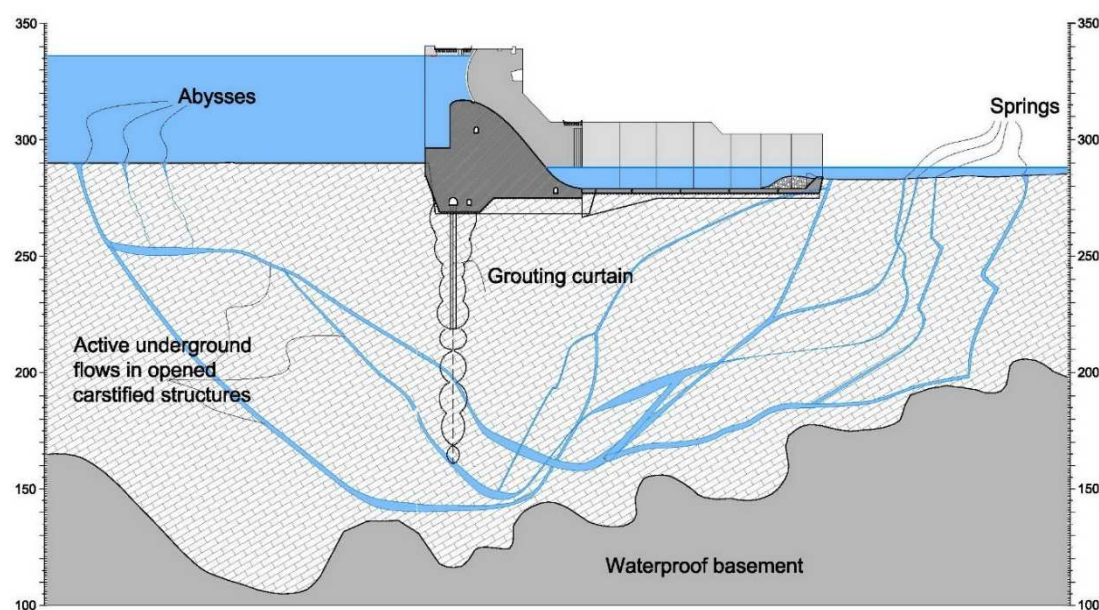
During the time prior to the reservoir filling, the karst forms under the local base level of erosion were predominantly filled with secondary material, and the erosion process took place along relatively small parts of the cracks, at small hydraulic gradients. With the construction of the dam and the reservoir formation, the hydraulic gradient increased dramatically, which led to a significant increase in flow rates and the development of the erosion process through rupture shapes under the dam body (Figure 5). The erosion involved the rinsing of milonite zones of larger rupture forms and Paleokarst structures filled with secondary material.

Figure 5. Process of the material rinsing under the dam body under the influence of the reservoir

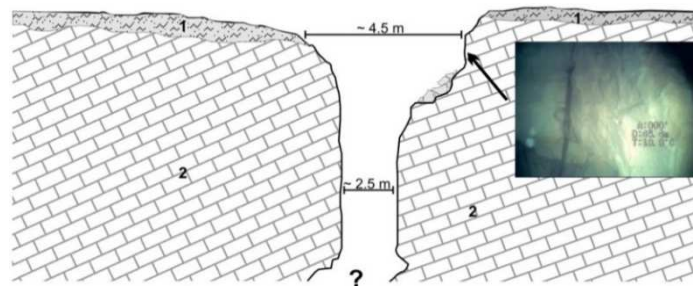
A "great abyss", among others, was detected on the basis of the results of the underwater video camera investigations. Based on the recorded size of this abyss, as well as the behavior of the equipment used to conduct the survey, it was estimated that this location is of exceptional importance for the water seepage process under the dam body.

Measuring net was constructed to determine the characteristics of this abyss, which is lowered to the abyss. The position and speed of the water at the entrance to the abyss were then recorded using a purpose-built measuring console. This study found that the inlet changes from a slight channel slope into a steeper part, and the area of the

irregular opening is 16 m<sup>2</sup>. Further, the channel narrows after 5 - 6 m in depth to a fairly regular cylindrical shape, which is several meters long with an approximate diameter of 2.5 m or 5 m<sup>2</sup>, but with significantly higher speeds (Figure 12).

**Figure 12.** Characteristic profiles of the inlet sink channel

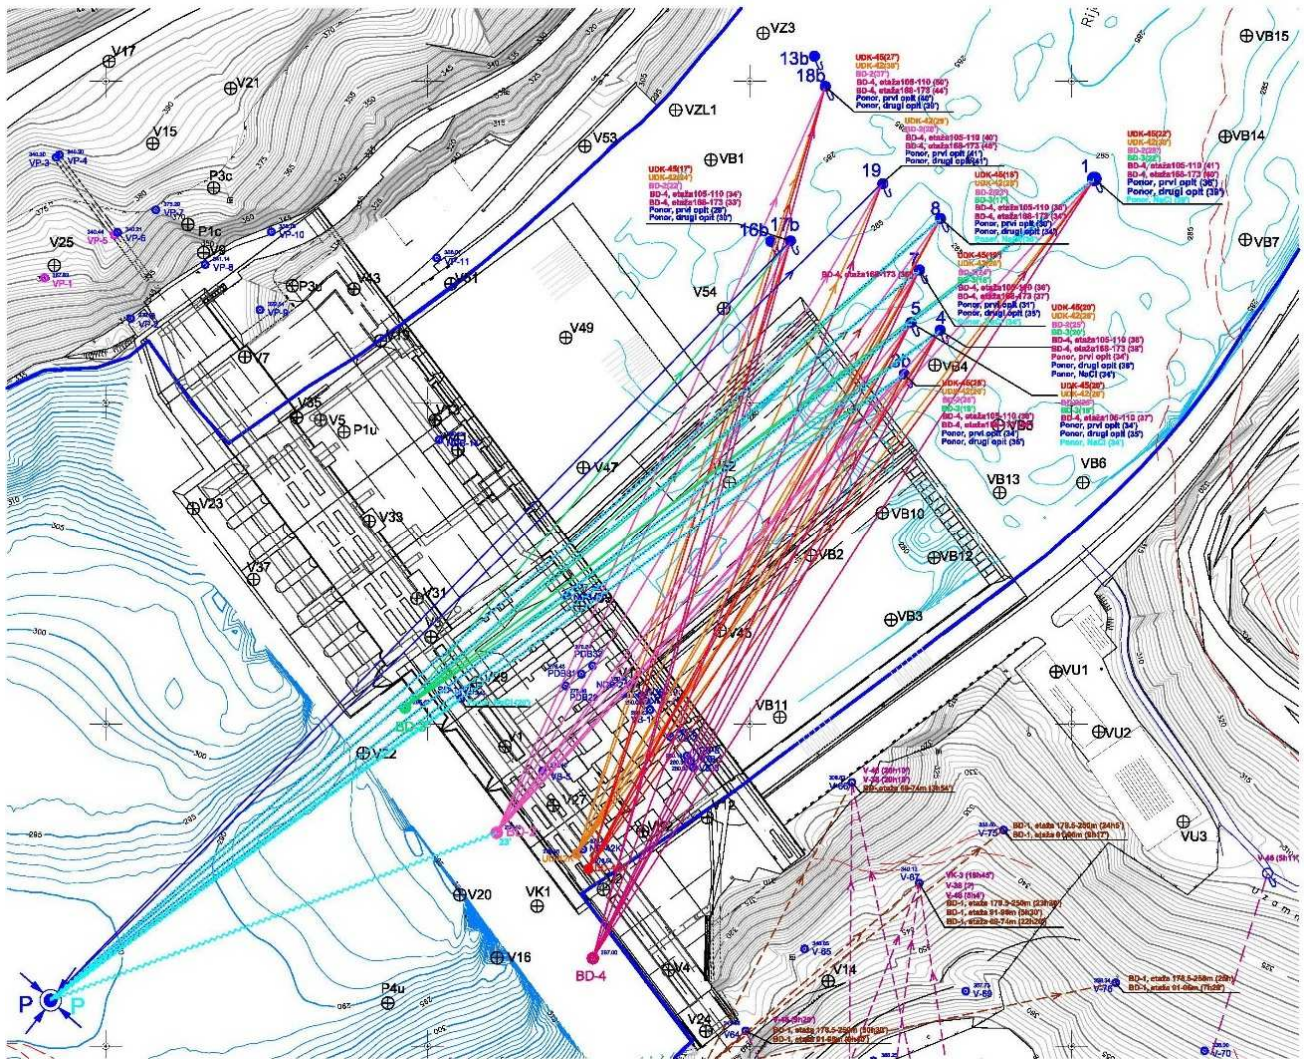
The tracer tests with fluorescein sodium established the connection of the great abyss with the sources in the Drina riverbed downstream of the dam. The nature of the connection is such that, at each tracer test, the tracer first appeared at the source located in the left part of the riverbed (source number 17b in Figure 16), and then in the central part (sources 8, 7, 5, 3b and 4, as presented). A little later, but with the longest exit wave duration, the tracer appeared at a large source (no. 1). The last sources where the tracer appears are located downstream, towards the left bank (no. 13b and 18b). Tracer tests performed in boreholes and piezometers also identified underground connections to all sources downstream of the dam with the same order of tracer occurrence as in the sinkhole tracing.

**Figure 19.** *Connections of boreholes and sinkholes upstream of the dam with downstream sources identified within the repair design development*

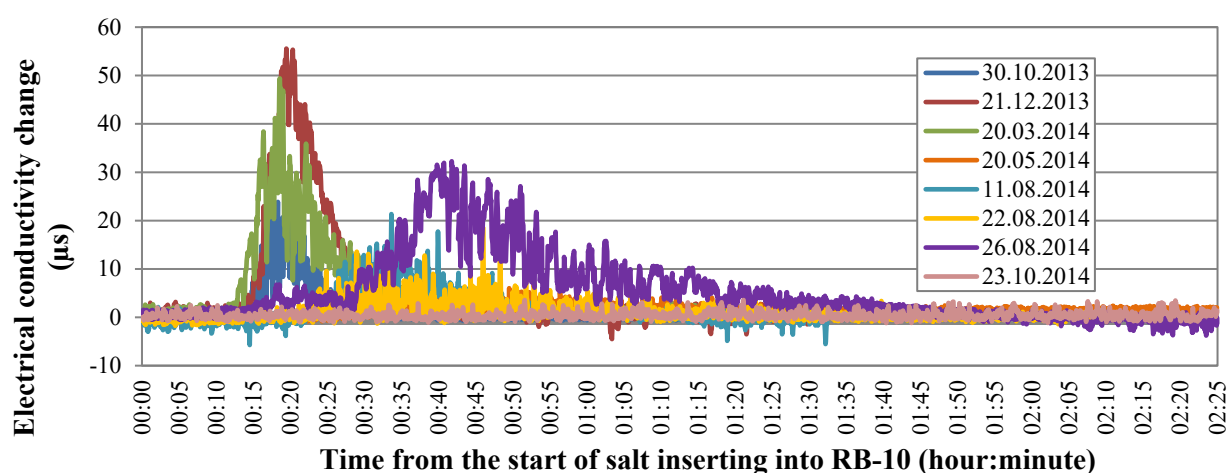
**Figure 22.** Changes in electrical conductivity at source 17b during salt tracer test at different characteristic moments of material installation

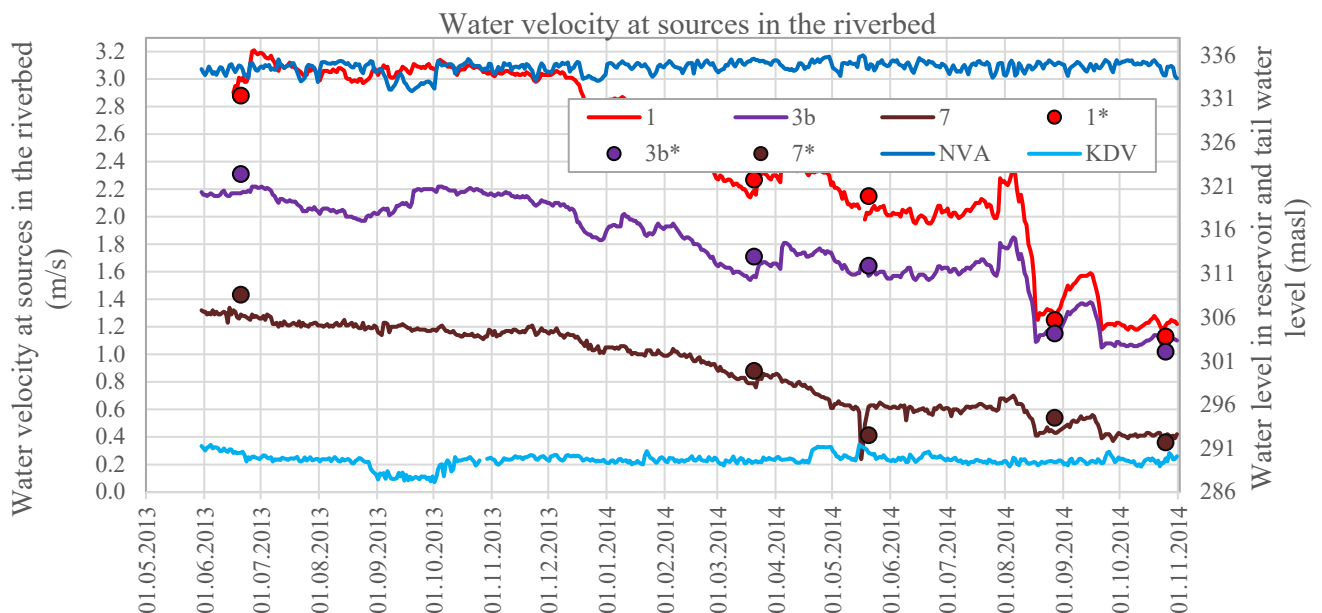
**Figure 27.** Example of comparative presentation of measured and calculated values of water velocities at sources (computing values tagged with \*)

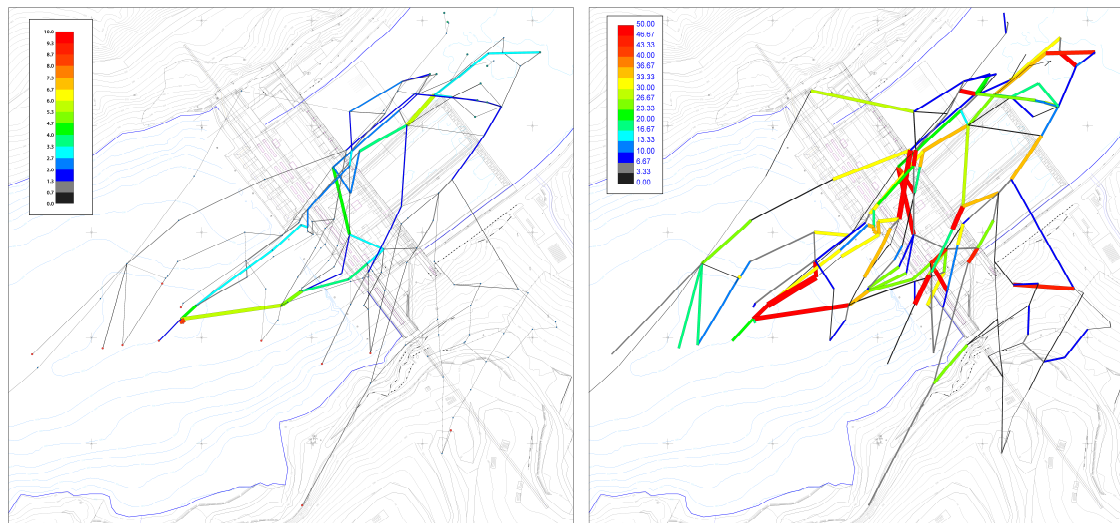
Simulation on a hydraulic model with the adopted topology and characteristics of flows provides all hydraulic sizes. They serve as the base for analysis and definition of dominant directions of water movement under the dam body. The following figures show the results of the hydraulic computation according to discharges (first figure) as well as the real sizes of underground flows (second figure), Figure 28.

**Figure 28.** Results of discharge and size computations for underground flows

The quality of the estimation is very good, given the complexity of the processes that have been modeled. By comparing the computed and measured values, according to the available observed data, we can observe very good matches.

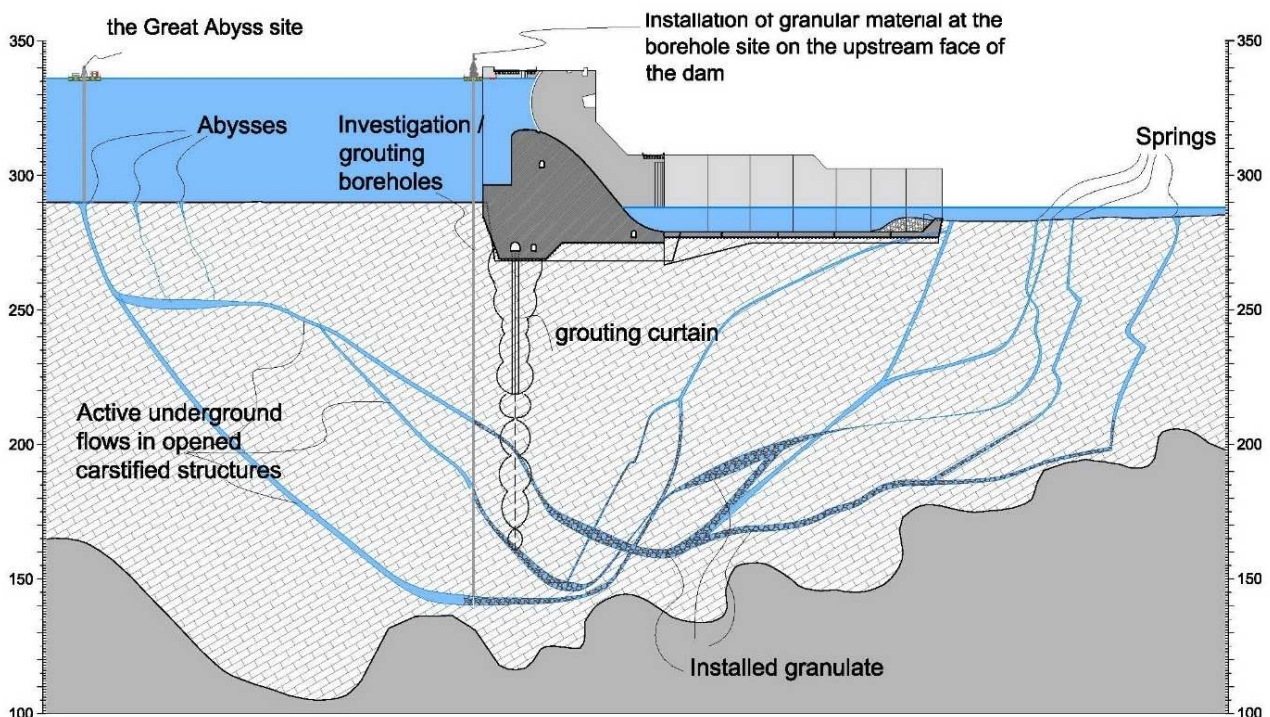
*Figure 29. Concept of repair works*

According to the adopted concept, the installation of inert material should be carried out from reliable predefined locations, as the entrance to the karst system upstream of the dam, i.e., the existing grout curtain. Then, after velocities is reduced, permanent sealing is to be implemented under more favorable conditions (Figure 29).

The stage of primary filling of cavities to reduce streaming velocities consists of filling streaming channels with an inert "filler", which should be adapted to the shape and size of the space to be filled, but also to the procedure applied in the subject filling.

The insertion of large quantities of mineral aggregate into existing cavities inevitably reduces discharge profile and transforms the streaming through planar cavities into streaming through a porous medium, with cavities evenly distributed in the space, and thus reduces both the discharge profile and the water streaming velocity, and thus the reduction of the total discharge is significant.

The final permanent sealing phase included the implementation of the second phase works. In improved conditions after the completion of the first phase works, the second phase included grouting with respective masses that will fill the remaining cavities in the radius of activities and harden together with the already inserted inert material.

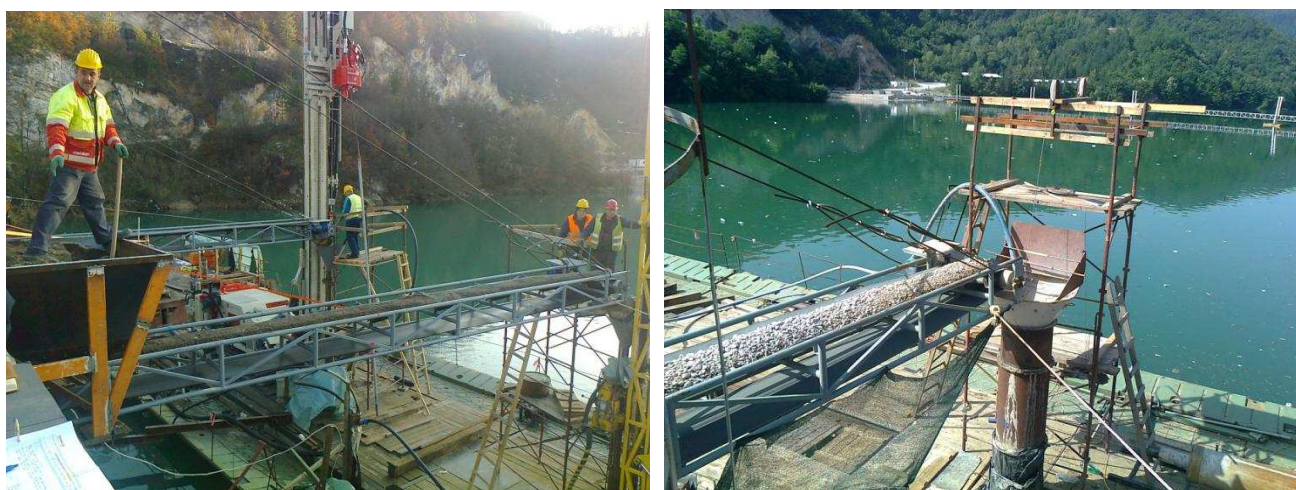
**Figure 30.** Installation of granular material through boreholes of smaller and larger diameter

The installation of granular material continued at the borehole site on the upstream face of the dam in borehole RB-10. The initial phase of material installation was carried out as a test, in order to avoid congestion with the material. The material installation was carried out through the PQ cladded pipes of the drilling set, Ø122 mm in diameter, directly above the cavern which the material is installed. In the initial phase, 0-4 mm granular material was installed, at a very low speed, and over time, after the analyses, the installation speed was increased and adapted to the existing conditions. After the test installation, the mechanical installation of granular material was initiated with conveyor belts, first in borehole RB-10, and then in boreholes RB-4 and B-15. Through the PQ drilling set Ø122 mm, the maximum realized installation capacity was 4 m<sup>3</sup>/h (Figure 30, left).

Larger diameters provided for a much faster installation of the granulate. Material jams occurred at higher installation speeds. The installation was carried out by gradually increasing the speed through expanded non-cased boreholes - from the initial test speed of 1 m<sup>3</sup>/h, to a maximum of 22 m<sup>3</sup>/h (Figure 30, right).

During 2013 and 2014, a total installed volume was about 37 000 m<sup>3</sup>.

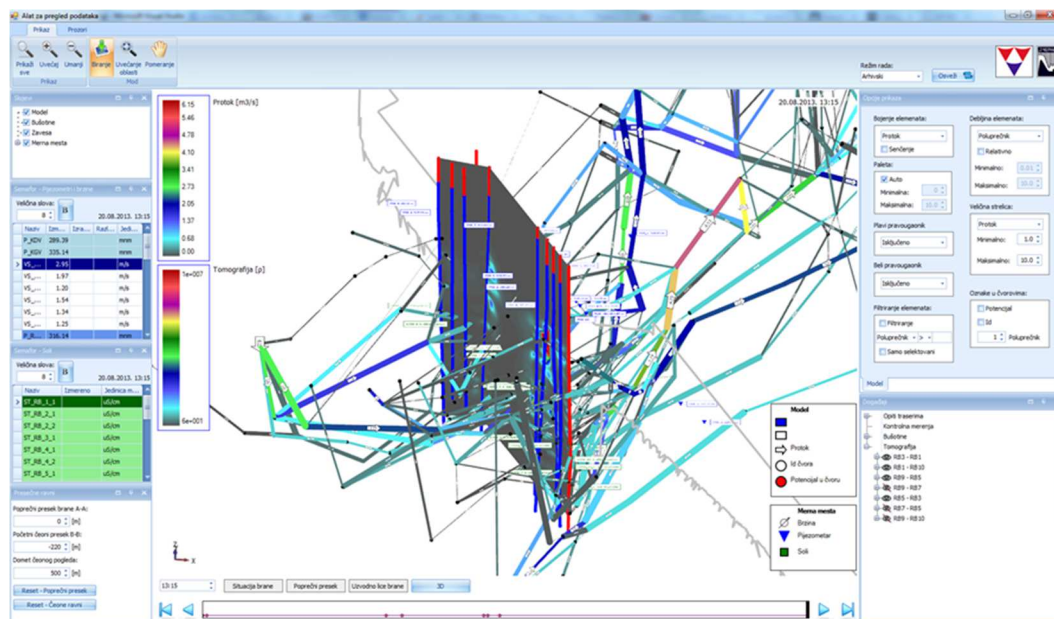
Figure 31. User application for the system state monitoring

The collection, analysis and processing of data obtained by the monitoring system, data on the installation of materials and other information recorded in the field were permanently performed during the repair works. Subject data were adequately analyzed via the presented mathematical models (Figure 31).

During the installation of granular materials, the recipes (mixtures) of granulation were adjusted - the material that was installed at individual installation locations - based on the implemented computations, so that the material is taken to the farthest parts of the underground channel system, but also that no major quantity is brought out at downstream sources. A significant filling of the system of underground structures was achieved exactly with this adjustment of the granulation.
