Mining and Metallurgy Engineering Bor

2/2022

REHABILITATION OF THE LANDSLIDE AT THE "LANDFILL 3" IN THE ZONE OF THE ČUKARU PEKI FLOTATION TAILING DUMP**

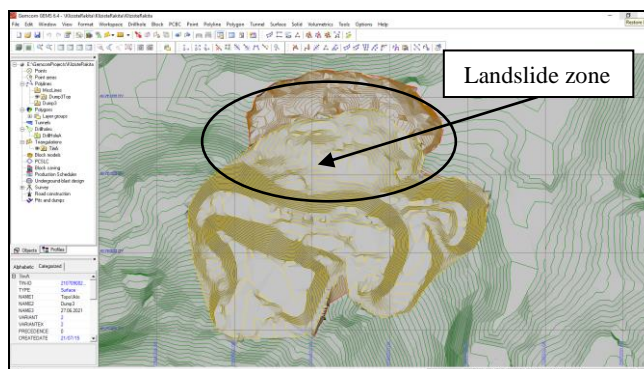
Figure 3 2D view of the field and landfill model

Based on the geotechnical profiles, a 3D model [10-13] of the field and landfill was made in the Gems program, Figures 3 and 4.
