Ljubiša Obradović^{*1}, Sandra Milutinović^{*2}, Srdana Magdalinović^{*3}, Sanja Petrović^{*4}

INTEGRATED DISPOSAL OF MINING WASTE, AN EXAMPLE OF REHABILITATION THE DAMAGED EMBANKMENT AT THE RTH TAILING DUMP BY THE MINE OVERBURDEN**

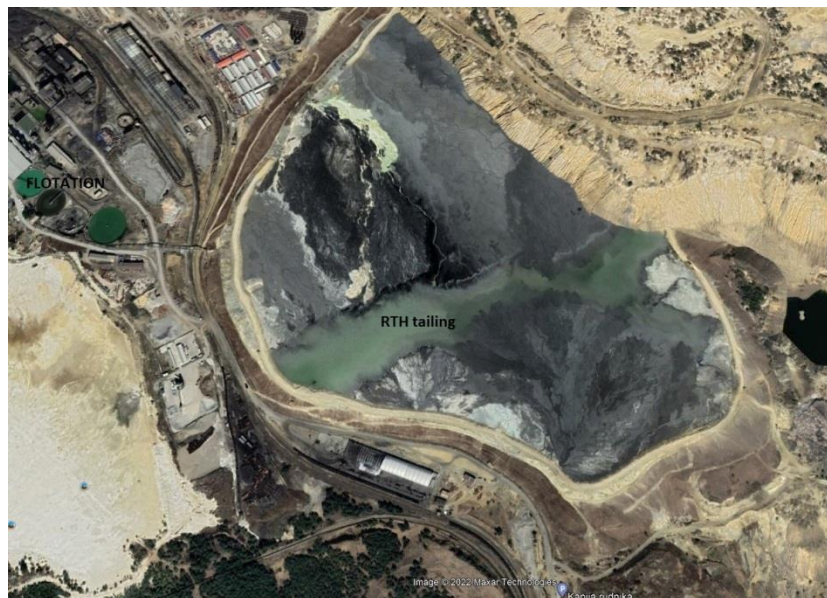
Figure 1 Flotation tailing dump RTH (Google Earth source, April 2021)

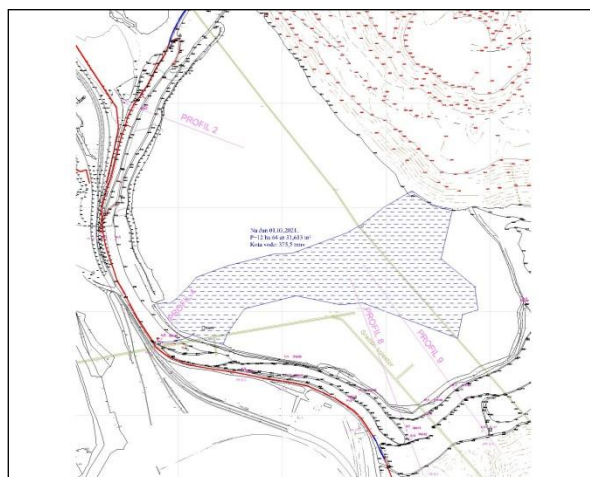
profiles is shown in Figure 6 and Table 1. Table 2 shows the physical and mechanical parameters of flotation tailings and Table 3 the physical and mechanical parameters for disposed mine waste [6].

Figure 6 Position of analysis profiles
